## **LaCygne Unit 1 SCR Graduated Straightening Grid Project**

Scott Hiedeman, KCP&L  
Reid Thomas and Dale Pfaff, Fuel Tech, Inc.  
Diane Fischer, Black & Veatch

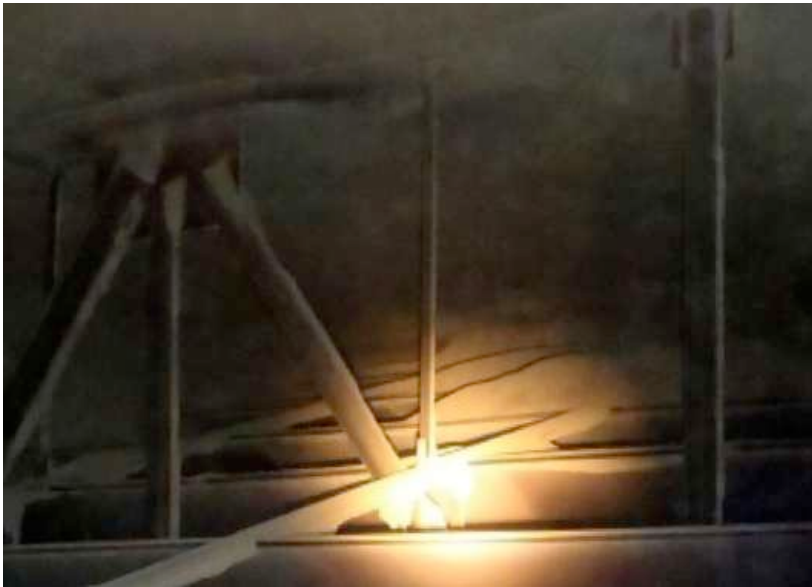
**Figure 1a:** Flyash on Turning Vanes

In the Fall 2012, LaCygne vacuumed 2,900,000 lbs. of flyash from the Unit1 SCR after a 17-month operating cycle. This was twice the typical amount of flyash removed due to an extended operating cycle with a low demand load factor. However, the catalyst pluggage of approximately 50% was typical of previous operating cycles. The LaCygne SCR consists of two reactor casings separated by a common division wall. Flue gas would enter the SCR North Side B and South Side A of the SCR Hood to flow down through these separated casings (refer to flow model arrangement shown in Figure 2). Flyash would pile 5-6 ft deep near the SCR North to South Reactor casing division wall. The flyash accumulation caused high ash removal costs, catalyst replacement costs, high catalyst pressure drop and fan power costs, high ammonia slip and ammonia reagent costs, and outage critical path time. The flyash accumulation also caused unit capacity derates in combination with other draft losses. Excess flyash accumulations are shown in Figures 1a and 1b.

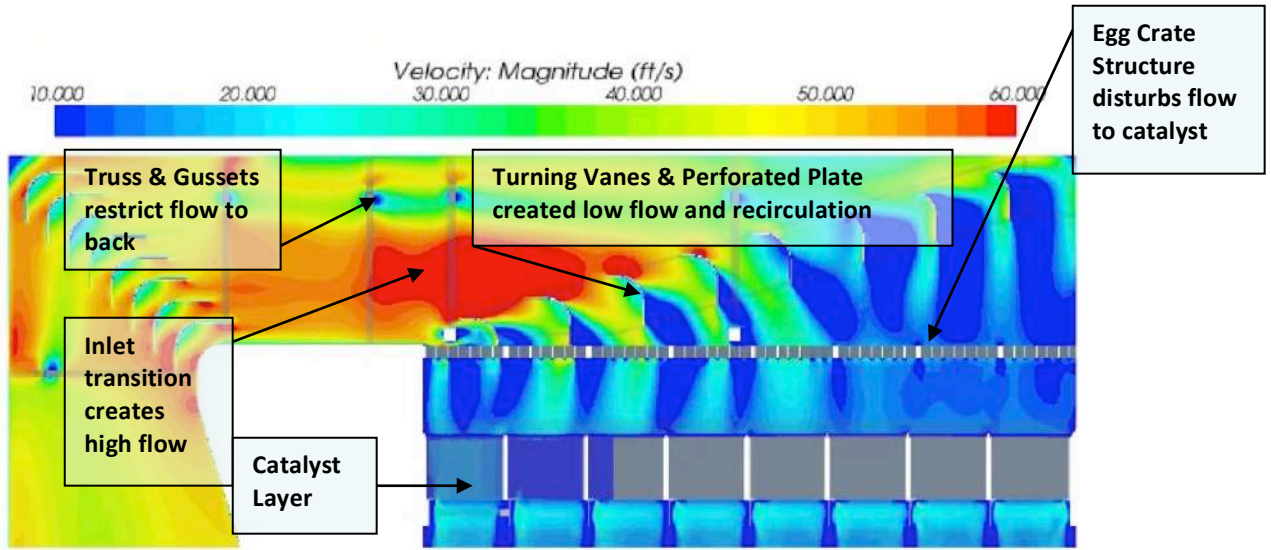
**Figure 3:** Baseline Velocity Results  
*SCR Hood area baseline velocity profile showing uneven velocities.*

To move PRB flyash through the catalyst, flue gas flow to the catalyst must be of uniform velocity, vertical, and without recirculation. In 2010, KCP&L LaCygne initiated Computational Fluid Dynamics (CFD) flow modeling with Fuel Tech, Inc. (FTEK) to determine the cause of flyash accumulation, and design potential devices to correct flow variances to the catalyst. The CFD analysis shown in Figures 3 and 4, indicated problem areas in SCR design flow including 1) SCR Inlet duct North-South contraction pushed flow to the lower 4 SCR Hood turning vanes; 2) trusses and large gusset plates in SCR inlet duct and hood restricted flow to the upper four SCR Hood turning vanes; 3) the turning vanes and perforated plate on top of the original Egg Crate flow straightening grid created flow recirculation zones that cause flyash dropout. The turning vanes also collected ash on horizontal surfaces due to low flow, and these ash piles sloughed off on FD Fan startups; 4) The Egg Crate structural support steel created flow disturbance that could not be corrected in the short distance to the first catalyst layer.

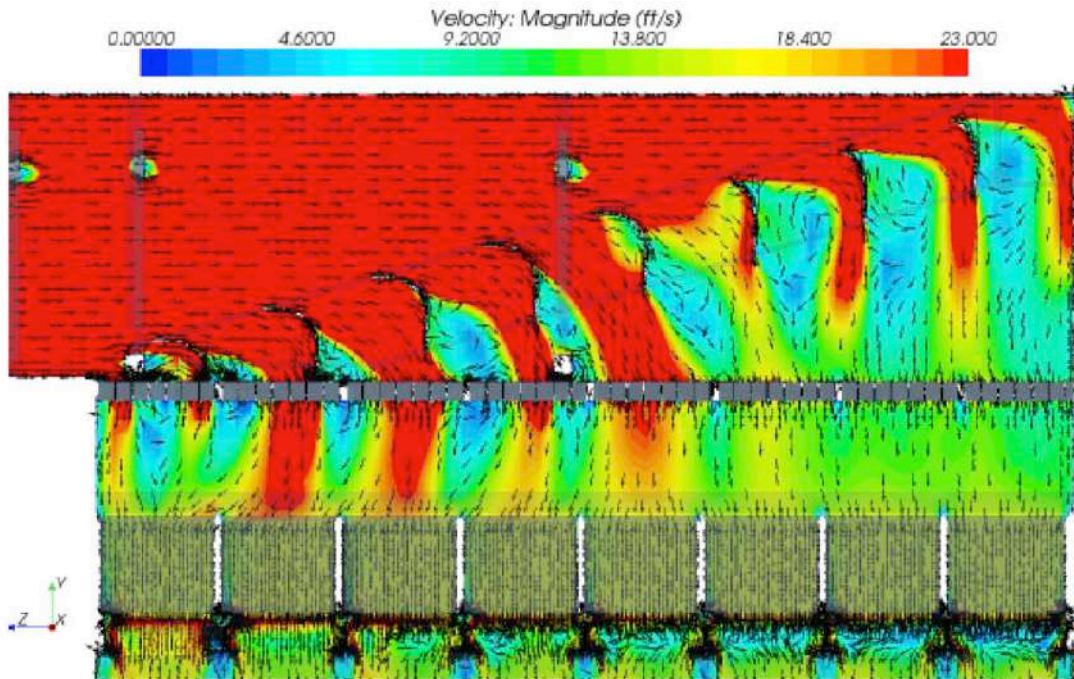
**Figure 4:** Baseline Velocity Vectors

The flow direction vectors show the flow recirculation zones behind the SCR Hood turning vanes. The flue gas recirculates behind these vanes, but the flyash does not follow this twisting route, and falls out on the catalyst layers.

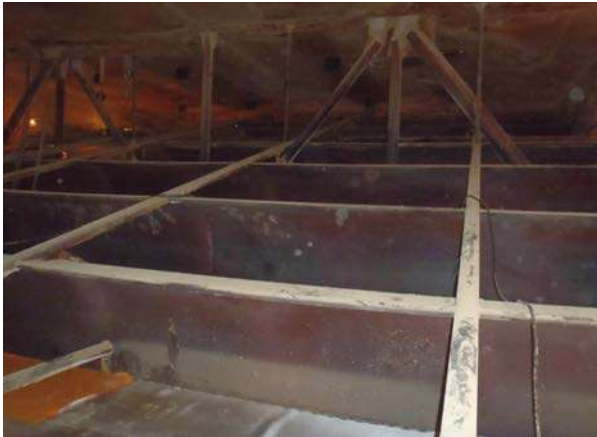
**Figure 5:** Turning Vanes & Center Truss

The final modification arrangement included demolition of the Turning Vanes in the hood of the SCR Reactors, and demolition of the original Egg Crate flow straightener, perforated plate and its support steel. Original equipment photos and Egg Crate demolition are shown in Figures 5 and 6.

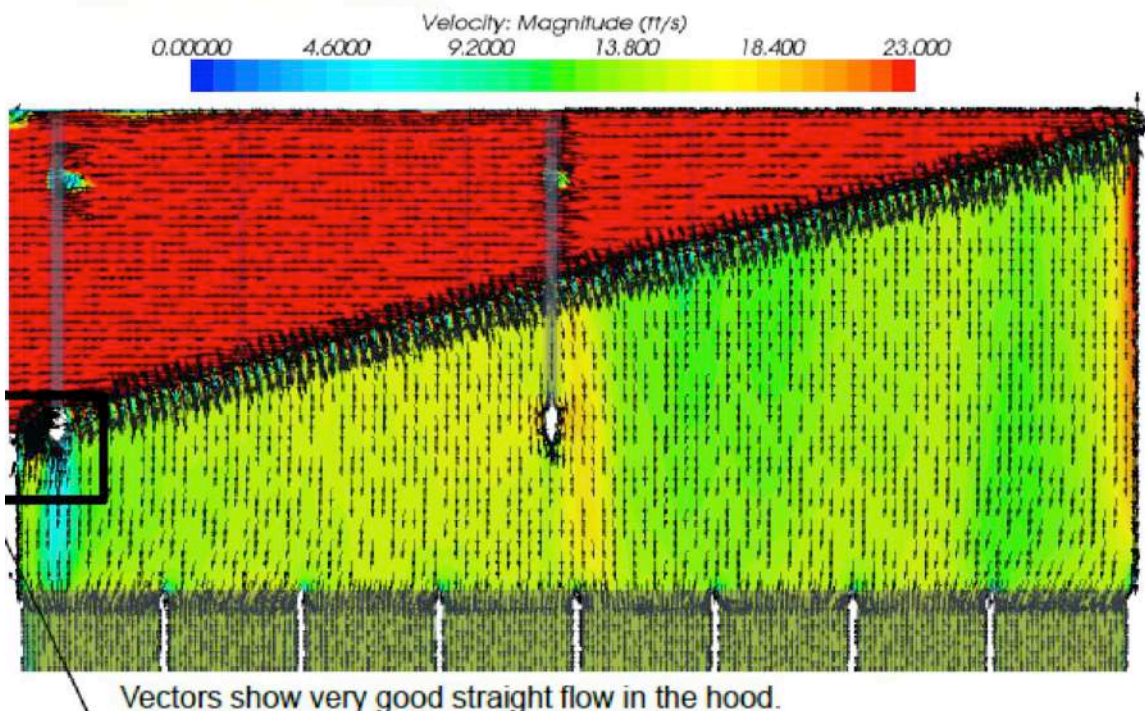
**Figure 7:** GSG Vector Flow

Graduated Straightening Grid (GSG) with perforated plate installation, and Egg Crate support removal produces vertical, non-recirculating, uniform velocity to the catalyst.

The selected arrangement installed the GSG device with perforated plate at the turning vane location. The GSG replaces the turning vane and Egg Crate functions by turning the flow 90-deg and aligning the flow up vertically to pass through the catalyst layers. A perforated plate was needed on the GSG blades leading edge to overcome the low flow at the SCR A & B division wall. The flow statistics did not quite reach the desired project goal of 100% of all flow velocities within +/- 15% of arithmetic mean. The final model showed flow distribution statistics with 91% of all analyzed flow velocities within +/- 15% (equal to 9.5% RMS). This was a significant improvement compared to the original, traditional turning vane design where 58% of flow velocities were within +/- 15% (17.5% RMS). The flue gas flow direction (velocity vectors) result was excellent, with the flow recirculation nearly eliminated, except at the two Truss systems, and the flow direction was vertical going into the catalyst.

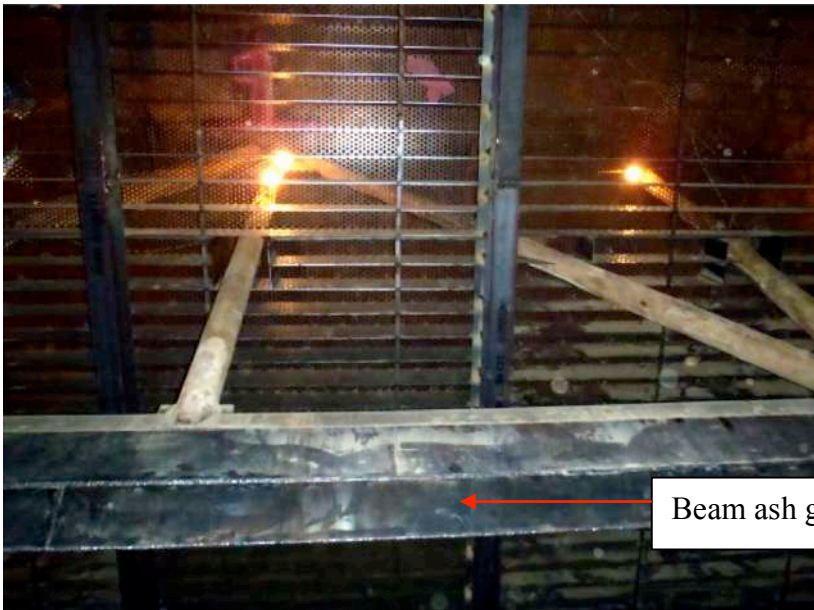
**Figure 9: GSG shown below center truss with ash guard on lower truss beam**

Beam ash guard with teepees

The fabrication of the GSG modules was straightforward. These modules were completed and shipped to the site prior to the installation crews needs during the October 1<sup>st</sup> outage. The late addition of the variable perforated plate added a complication to the fabrication schedule. Fabrication time at six different shops was secured to laser or plasma cut all the perforated plate piece parts. The final GSG device with perforated plate was installed as shown in Figures 8 and 9.

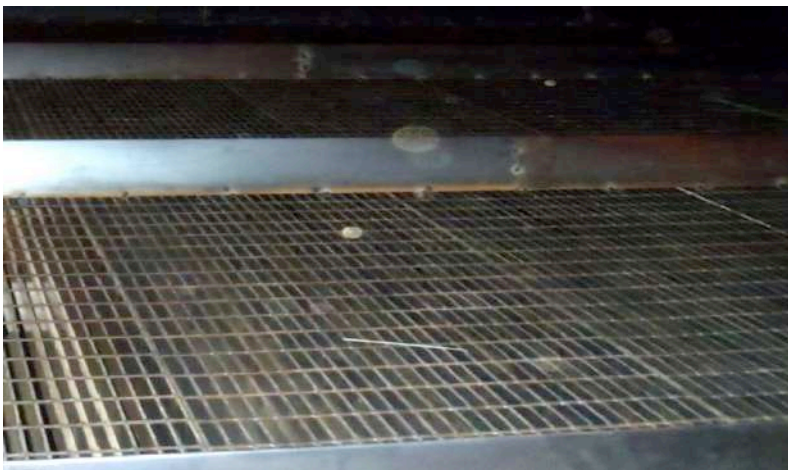
**Figure 11:** Grating Floor

The Egg Crate steel above Layer1 catalyst that was removed, also provided the catalyst removal cart wheel tracks. An alternate catalyst installation method needed to be developed. A grating floor was installed in catalyst Layer1. Future Layer1 catalyst installation will be by pallet carts. Catalyst was installed in Layers 2-3-4 during the 2012 outage to aid GSG construction sequence. Catalyst support beam teepee ash guards were installed on the grating floor to prevent PRB flyash stalagmites from growing up from the beams.

LaCygne catalyst seals were sloped similar to the beam guards shown in Figure 11. Catalyst support beam and loading monorail beam pockets were covered to prevent ash buildup. SCR Hood Truss beam pockets were covered, beam tops sloped to eliminate ash buildup, and beam bottoms fabricated into air foils to avoid recirculation zones. Refer to examples shown in Figure 12a and 12b.

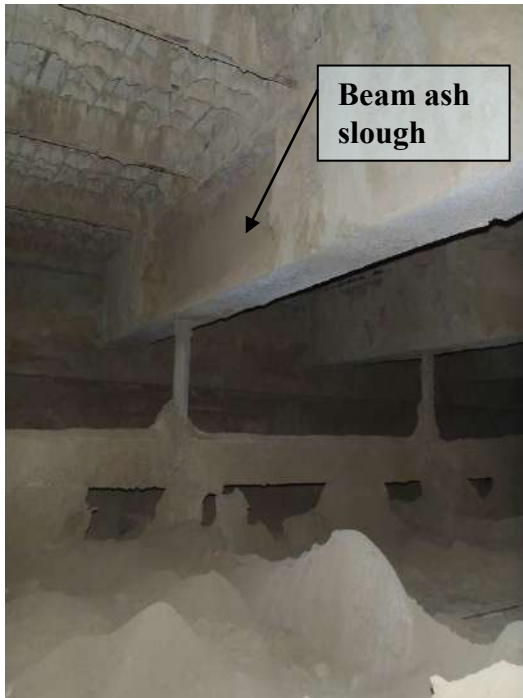
**Figure 12a:** Beam ash slough (left)

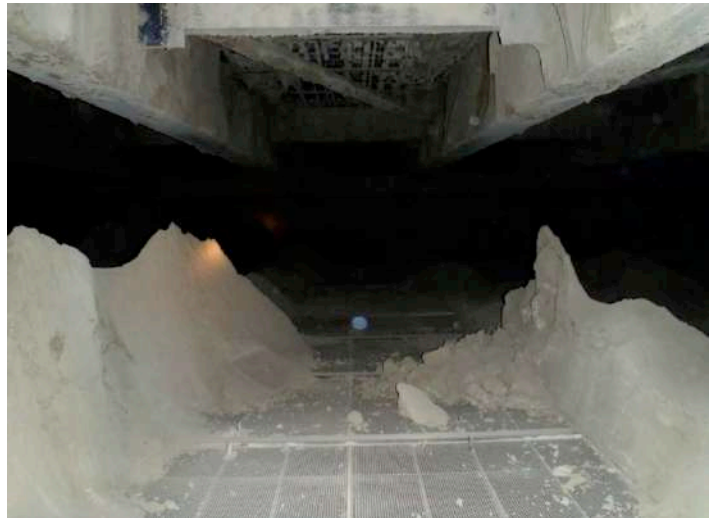
**Figure 12b:** Stalagmite from flat catalyst module seals (right)

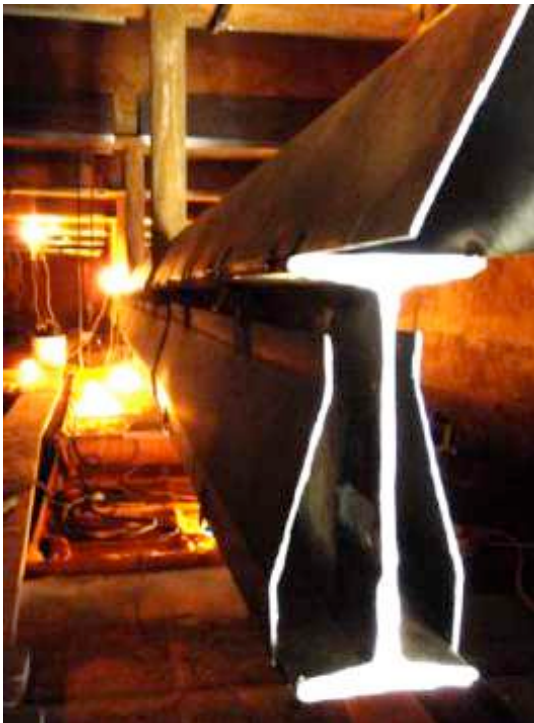
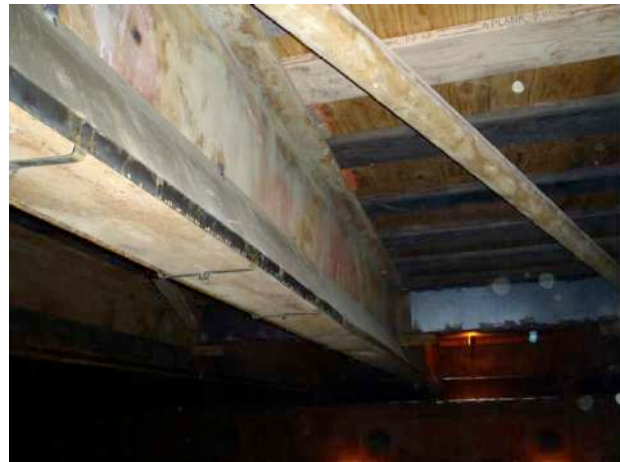
**Figure 13a:** Beam ash guard (left)  
**Figure 13b:** Beam ash guard (above)

PRB coal ash collects inside the SCR catalyst structural beam pockets. The ash in the deep beam pockets can slough off in large sections to cause bigger piles on the catalyst. Beam ash guards were installed to prevent ash accumulation.

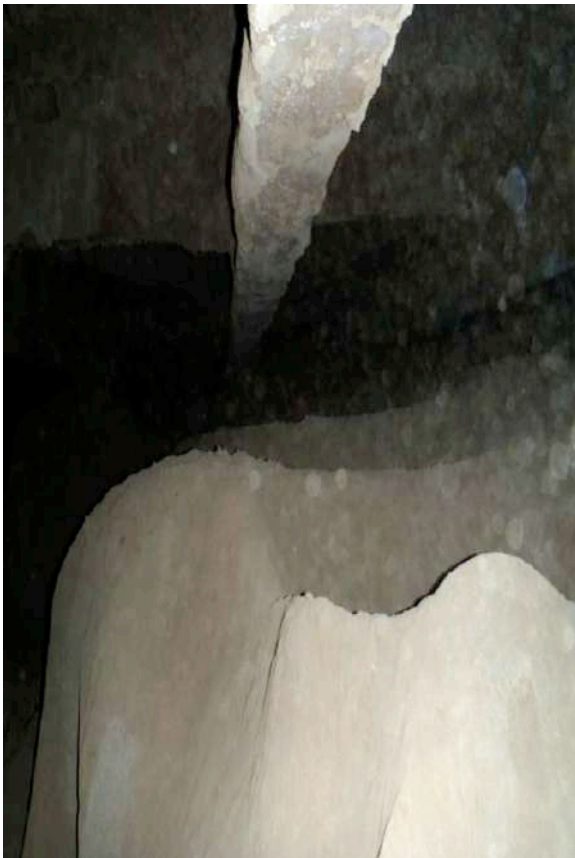
An SCR internal inspection after four months of operation showed excellent results at the SCR division wall. Figures 14a and 14b show the before and after success of GSG in providing uniform, vertical, and non-recirculating flow in the SCR Hood to prevent flyash accumulation.

**Figure 14a:** Photo taken on 10/01/2012 near division wall

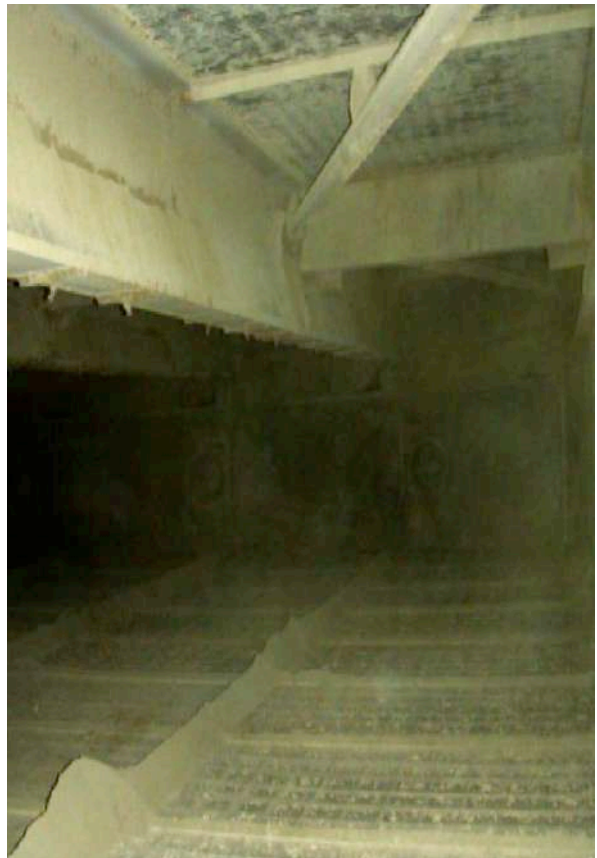
**Figure 14b:** Photo taken on 03/30/2013 near division wall.
